**Flood Control Project Maintenance
Levee Inspections**

Fall 2015 Levee Maintenance Deficiency Summary Report

Sacramento River Basin

Sutter Maintenance Yard Maintenance Area 0001

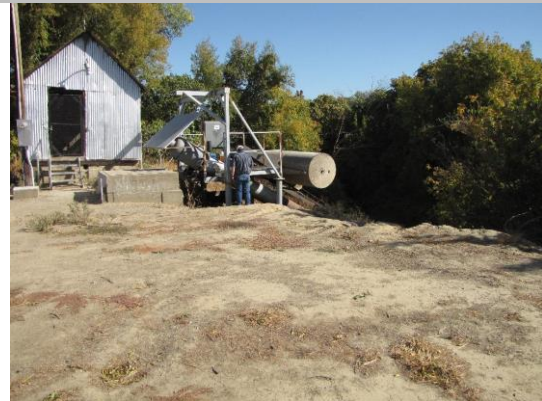
Photo 1 of 3 : UCIP_FA_2015_4788.jpg

Close up of appurtenances located about 100 feet NE of levee crossing.

UCIP Comments: 4/20/2015 Same as last inspection. No repairs have been made yet. Need pressure test/video inspection to determine integrity of pipe wall. WS-woody debris scattered along slope & bank. Erosion on bank near ditch. LS-discharge pipe heavily corroded & CMP section missing. This crossing was listed in the USACE Periodic Inspections as ID# USACE_CESPK_MA1C_2010_p_0097 for debris & encroachment within 15 feet. 7/18/2013 LS outlet was underwater and could not be inspected but nothing looks to have been changed. 12/17/2013 Same as last inspection. 6/18/2014 Same as last inspection.

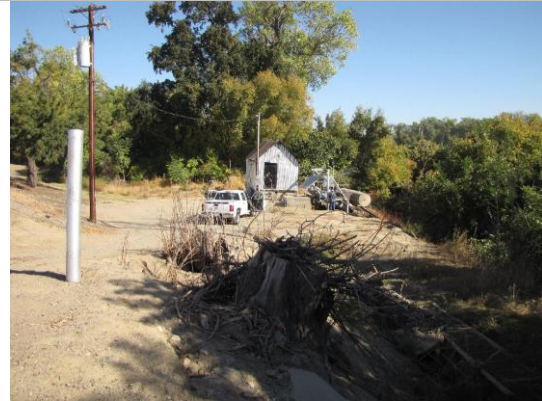
Photo 2 of 3 : UCIP_FA_2015_4789.jpg

Other appurtenances associated with crossing-Structure, pump, distribution box, and power pole located on WS bank.

Inspector Comments: FS_ID:44590
DS_ID:16431
EP_NO: 9481
FS_HLM: 1.197
Repair Type: Non-Urgent
Crossing Status: Found
UCIP Comments: 4/20/2015 Same as last inspection. No repairs have been made yet. Need pressure test/video inspection to determine integrity of pipe wall. WS-woody debris scattered along slope & bank. Erosion on bank near ditch. LS-discharge pipe heavily corroded & CMP section missing. This crossing was listed in the USACE Periodic Inspections as ID# USACE_CESPK_MA1C_2010_p_0097 for debris & encroachment within 15 feet. 7/18/2013 LS outlet was underwater and could not be inspected but nothing looks to have been changed. 12/17/2013 Same as last inspection. 6/18/2014 Same as last inspection.
FIELD_STRUCT_DESC: 36-inch corrugated metal pipe (CMP) through the levee, slide gate on the waterward slope. (ABO No. 9481-1974, Roberts Ditch Irrigation Company) Crossing penetrates the levee at an angle. Other appurtenances located at this crossing include slant pump, concrete distribution box and shed structure located 100 feet northeast from levee crossing. Flow is carried from concrete distribution box to slide gate via concrete lined ditch. This entry matches the Drainage and Irrigation Structure referenced in O&M manual (Station 63+53).

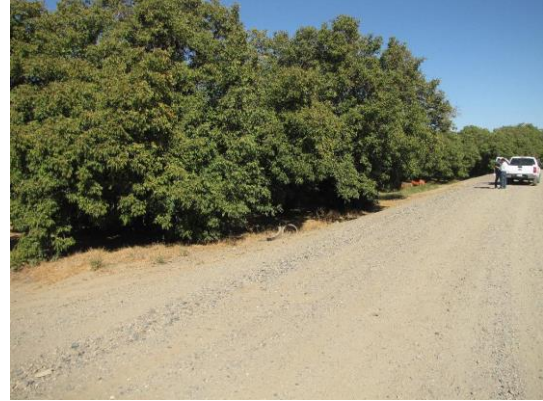
Photo 1 of 3 : UCIP_FA_2015_4791.jpg

Action/Comments					
Inspector Comments: FS_ID:44592					
DS_ID:16430					
EP_NO: 9487					
FS_HLM: 1.96					
Repair Type: Non-Urgent					
Crossing Status: Found					
UCIP Comments: 4/20/2015 WS pipe end is plugged about 50% by soil. Remove dirt and debris in riser. Outlet deformed and blocked over 50%. Debris-round concrete section on landward side. This crossing was listed in the USACE Periodic Inspections as ID#					
USACE_CESPK_MA1C_2010_p_0116 for crossing outlet deformed and clogged with dirt. 7/18/2013 WS pipe end has been reformed but is still clogged about 50% by sediment. 12/17/2013 Same as last inspection. 6/18/2014 Same as last inspection.					
FIELD_STRUCT_DESC: 1 of 2: 36-inch corrugated metal pipe (CMP) through the levee. Slide gates in CMP riser on the waterward slope. (ABO No. 9487-1974, Jimeno Rancho) This entry matches the Drainage and Irrigation Structure referenced in O&M manual (Station 103+18).

View of landward side looking upstream at crossing.

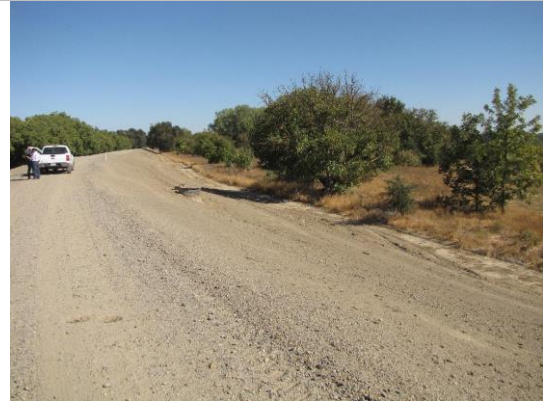
Photo 2 of 3 : UCIP_FA_2015_4818.jpg

Action/Comments					
Inspector Comments: FS_ID:44592					
DS_ID:16430					
EP_NO: 9487					
FS_HLM: 1.96					
Repair Type: Non-Urgent					
Crossing Status: Found					
UCIP Comments: 4/20/2015 WS pipe end is plugged about 50% by soil. Remove dirt and debris in riser. Outlet deformed and blocked over 50%. Debris-round concrete section on landward side. This crossing was listed in the USACE Periodic Inspections as ID#					
USACE_CESPK_MA1C_2010_p_0116 for crossing outlet deformed and clogged with dirt. 7/18/2013 WS pipe end has been reformed but is still clogged about 50% by sediment. 12/17/2013 Same as last inspection. 6/18/2014 Same as last inspection.					
FIELD_STRUCT_DESC: 1 of 2: 36-inch corrugated metal pipe (CMP) through the levee. Slide gates in CMP riser on the waterward slope. (ABO No. 9487-1974, Jimeno Rancho) This entry matches the Drainage and Irrigation Structure referenced in O&M manual (Station 103+18).

View of waterward side looking upstream at CMP riser on slope.

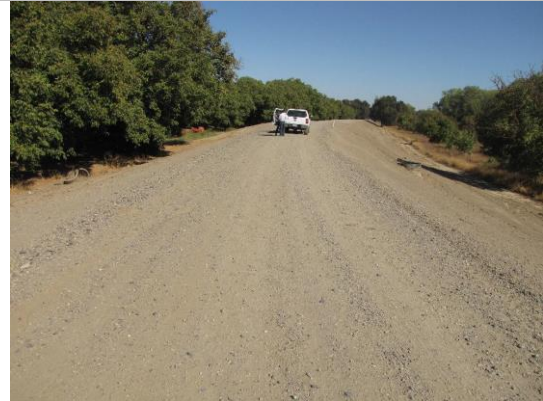
Photo 3 of 3 : UCIP_FA_2015_4819.jpg

Action/Comments					
Inspector Comments: FS_ID:44592					
DS_ID:16430					
EP_NO: 9487					
FS_HLM: 1.96					
Repair Type: Non-Urgent					
Crossing Status: Found					
UCIP Comments: 4/20/2015 WS pipe end is plugged about 50% by soil. Remove dirt and debris in riser. Outlet deformed and blocked over 50%. Debris-round concrete section on landward side. This crossing was listed in the USACE Periodic Inspections as ID#					
USACE_CESPK_MA1C_2010_p_0116 for crossing outlet deformed and clogged with dirt. 7/18/2013 WS pipe end has been reformed but is still clogged about 50% by sediment. 12/17/2013 Same as last inspection. 6/18/2014 Same as last inspection.					
FIELD_STRUCT_DESC: 1 of 2: 36-inch corrugated metal pipe (CMP) through the levee. Slide gates in CMP riser on the waterward slope. (ABO No. 9487-1974, Jimeno Rancho) This entry matches the Drainage and Irrigation Structure referenced in O&M manual (Station 103+18).

Overview of levee crown and slopes looking upstream towards crossing.

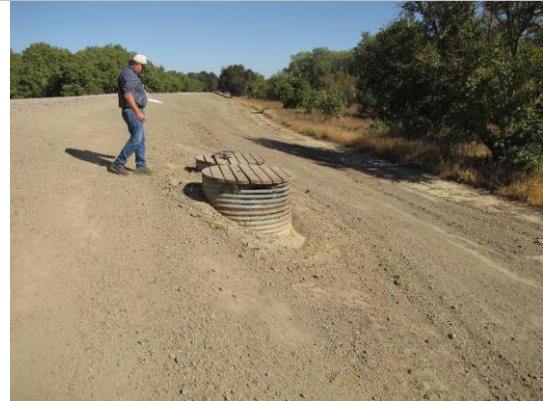
Photo 1 of 3 : UCIP_FA_2015_3729.jpg

Action/Comments					
Inspector Comments: FS_ID:44593					
DS_ID:17565					
EP_NO: 9487					
FS_HLM: 1.961					
Repair Type: Non-Urgent					
Crossing Status: Found					
UCIP Comments: 4/20/2015 WS pipe end plugged about 50% by soil.WS-remove dirt and debris in riser. Outlet deformed and blocked over 50%. Burrow activity near outlet on waterward slope. Debris around concrete section on landward side. This crossing was listed in the USACE Periodic Inspections as ID#					
USACE_CESPK_MA1C_2010_p_0116 for crossing outlet deformed and clogged with dirt.7/18/2013 WS pipe end has been reformed but is still partially blocked with dirt and debris.12/17/2013 Same as last inspection.6/18/2014 Same as last inspection.					
FIELD_STRUCT_DESC: 2 of 2: 36-inch corrugated metal pipe (CMP) through the levee. Slide gates in CMP riser on the waterward slope. (ABO No. 9487-1974, Jimeno Rancho) This entry matches the Drainage and Irrigation Structure referenced in O&M manual (Station 103+18).

View of CMP risers located on waterward slope.

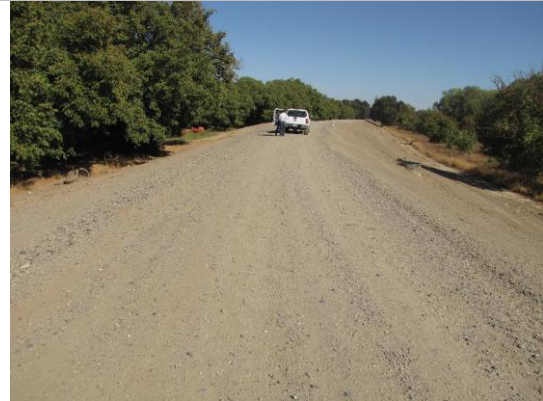
Photo 2 of 3 : UCIP_FA_2015_4820.jpg

Action/Comments					
Inspector Comments: FS_ID:44593					
DS_ID:17565					
EP_NO: 9487					
FS_HLM: 1.961					
Repair Type: Non-Urgent					
Crossing Status: Found					
UCIP Comments: 4/20/2015 WS pipe end plugged about 50% by soil.WS-remove dirt and debris in riser. Outlet deformed and blocked over 50%. Burrow activity near outlet on waterward slope. Debris around concrete section on landward side. This crossing was listed in the USACE Periodic Inspections as ID#					
USACE_CESPK_MA1C_2010_p_0116 for crossing outlet deformed and clogged with dirt.7/18/2013 WS pipe end has been reformed but is still partially blocked with dirt and debris.12/17/2013 Same as last inspection.6/18/2014 Same as last inspection.					
FIELD_STRUCT_DESC: 2 of 2: 36-inch corrugated metal pipe (CMP) through the levee. Slide gates in CMP riser on the waterward slope. (ABO No. 9487-1974, Jimeno Rancho) This entry matches the Drainage and Irrigation Structure referenced in O&M manual (Station 103+18).

View of levee crown and slopes looking upstream at crossing.

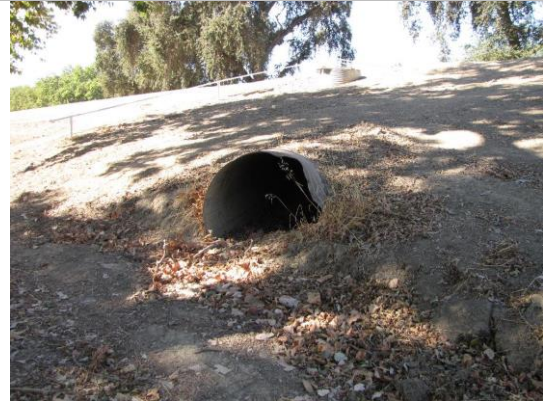
Photo 1 of 3 : UCIP_FA_2015_3730.jpg

Action/Comments					
Inspector Comments: FS_ID:44594 DS_ID:16429 EP_NO: 9472 FS_HLM: 2.281 Repair Type: Non-Urgent Crossing Status: Found UCIP Comments: 4/20/2015 Same as last inspection. Remove debris from riser. Landward inlet is blocked by over 50%. This crossing was listed in the USACE Periodic Inspections as ID# USACE_CESPK_MA1C_2010_p_0128 for sediment build up at inlet (landward side) and debris inside riser. 7/18/2013 Same as last inspection. 12/17/2013 Same as last inspection. 6/18/2014 Same as last inspection. FIELD_STRUCT_DESC: 54-inch corrugated metal drain pipe through the levee. Slide gate in CMP riser on the waterward slope. 48-inch corrugated metal pipe at landward slope. This crossing crosses the levee at an angle. (ABO No. 9472-1974, Ballard) This entry matches the Drainage and Irrigation Structure referenced in O&M manual (Station 120+00) dated 1955. FS Date: 04/21/2015

View of outlet located at waterward toe.

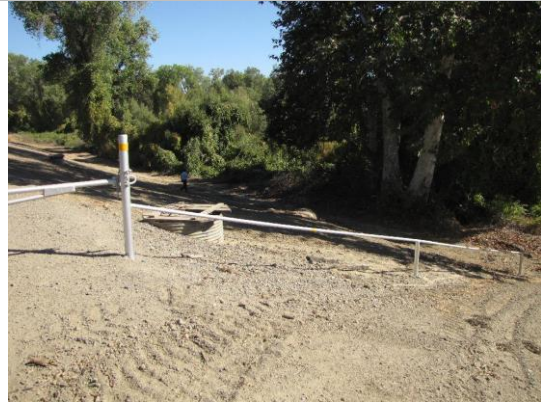
Photo 3 of 3 : UCIP_FA_2015_3732.jpg

Action/Comments					
Inspector Comments: FS_ID:44594 DS_ID:16429 EP_NO: 9472 FS_HLM: 2.281 Repair Type: Non-Urgent Crossing Status: Found UCIP Comments: 4/20/2015 Same as last inspection. Remove debris from riser. Landward inlet is blocked by over 50%. This crossing was listed in the USACE Periodic Inspections as ID# USACE_CESPK_MA1C_2010_p_0128 for sediment build up at inlet (landward side) and debris inside riser. 7/18/2013 Same as last inspection. 12/17/2013 Same as last inspection. 6/18/2014 Same as last inspection. FIELD_STRUCT_DESC: 54-inch corrugated metal drain pipe through the levee. Slide gate in CMP riser on the waterward slope. 48-inch corrugated metal pipe at landward slope. This crossing crosses the levee at an angle. (ABO No. 9472-1974, Ballard) This entry matches the Drainage and Irrigation Structure referenced in O&M manual (Station 120+00) dated 1955. FS Date: 04/21/2015

View of waterward side looking at slope and channel.

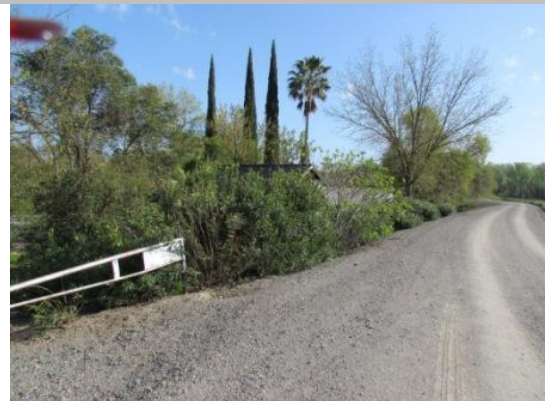
Photo 1 of 1 : FA_2015_MA0001_297_20_20150910_00009.jpg

LM Start	2.53	Rating **	U	Issue No.	20
LM End	2.55	Issue Type +	En	Location *	LS
Category	Earthen Levee			GPS Latitude/Longitude	
				Start	End
Item	Encroachments			39.239750 °	39.239955 °
				-122.010390 °	-122.010090 °
DWR ID	DWR_MA0001_01_s_2012_20				
Action/Comments					
Building

View of the house next to the levee.

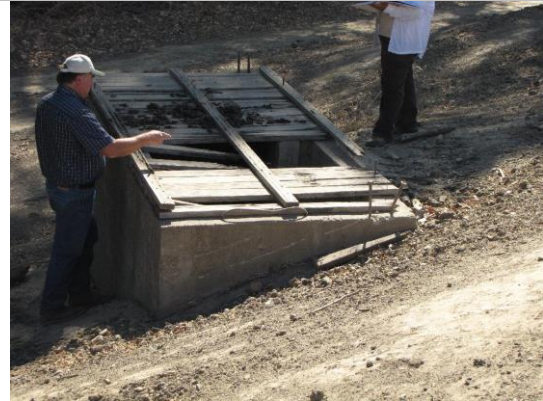
Photo 1 of 3 : UCIP_FA_2015_3736.jpg

Action/Comments					
Inspector Comments: FS_ID:44741					
DS_ID:16416					
EP_NO: 9474					
FS_HLM: 2.869					
Repair Type: Urgent					
Crossing Status: Found					
UCIP Comments: 4/20/2015 Positive closure device is missing and water cannot be prevented from flowing through pipe during high water. During high water flow goes through levee. Missing positive closure device on waterward side. This structure appears abandoned- slide gates have been removed. Crossing needs to be properly abandoned. This crossing was listed in the USACE Periodic Inspection as ID# USACE_CESPK_MA1C_2010_p_0169 for concrete box partially filled with dirt. 7/18/2013 Same as last inspection. 12/17/2013 Same as last inspection. 6/18/2014 Same as last inspection.					
FIELD_STRUCT_DESC: 1 of 2: 60-inch concrete pipe through the levee. Slide gates in concrete well at the waterward toe. (ABO No. 9474-1974, George R. Zumwalt) This entry matches the Drainage and Irrigation Structure referenced in O&M manual (Station 150+06). O&M description is for 2-5 foot by 5 foot concrete culverts 2-slide gates hand operated. Culvert constructed with wing walls and gate well.

Concrete distribution box located on waterward shoulder.

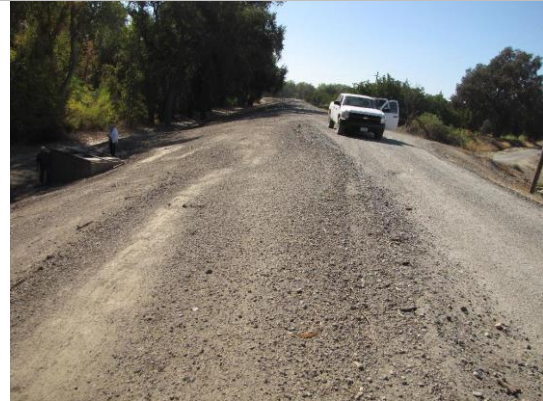
Photo 2 of 3 : UCIP_FA_2015_3737.jpg

UCIP Comments: 4/20/2015 Positive closure device is missing and water cannot be prevented from flowing through pipe during high water. During high water flow goes through levee. Missing positive closure device on waterward side. This structure appears abandoned- slide gates have been removed. Crossing needs to be properly abandoned. This crossing was listed in the USACE Periodic Inspection as ID# USACE_CESPK_MA1C_2010_p_0169 for concrete box partially filled with dirt. 7/18/2013 Same as last inspection. 12/17/2013 Same as last inspection. 6/18/2014 Same as last inspection.

Overview of levee crown looking downstream at crossing.

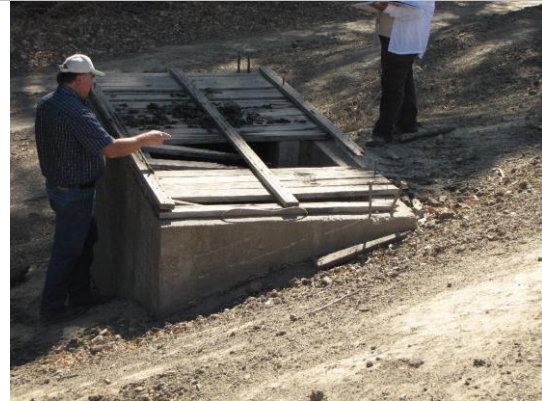
Photo 1 of 3 : UCIP_FA_2015_4964.jpg

Inspector Comments: FS_ID:44742
DS_ID:17567
EP_NO: 9474
FS_HLM: 2.87
Repair Type: Urgent
Crossing Status: Found
UCIP Comments: 4/20/2015 Positive closure device is missing and water cannot be prevented from flowing through pipe during high water. During high water flow goes through levee. Missing positive closure device on waterward side. This structure appears abandoned- slide gates have been removed. Crossing needs to be properly abandoned. This crossing was listed in the USACE Periodic Inspection as ID# USACE_CESPK_MA1C_2010_p_0169 for concrete box partially filled with dirt. 7/18/2013 Same as last inspection. 12/17/2013 Same as last inspection. 6/18/2014 Same as last inspection.
FIELD_STRUCT_DESC: 2 of 2: 60-inch pipe through the levee. Crossing angles through levee. Slide gates in concrete well at the waterward toe. Slide gates missing. (ABO No. 9474-1974, George R. Zumwalt) This entry matches the Drainage and Irrigation Structure referenced in O&M manual (Station 150+06). O&M description is for 2-5 foot by 5 foot concrete culverts 2-slide gates hand operated. Culvert constructed with wing walls and gate well.

Close up view of concrete distribution box located on waterward shoulder.

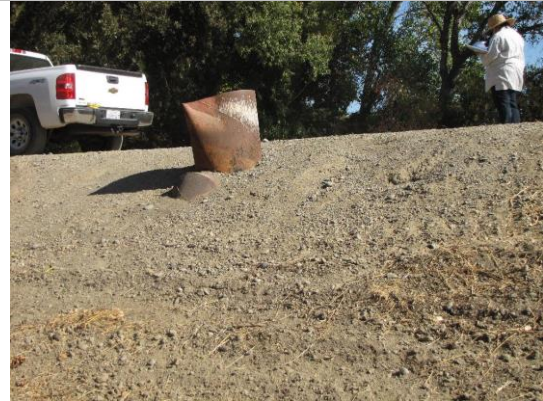
Photo 1 of 3 : UCIP_FA_2015_6490.jpg

Siphon breaker and section of exposed pipe located on landward shoulder.

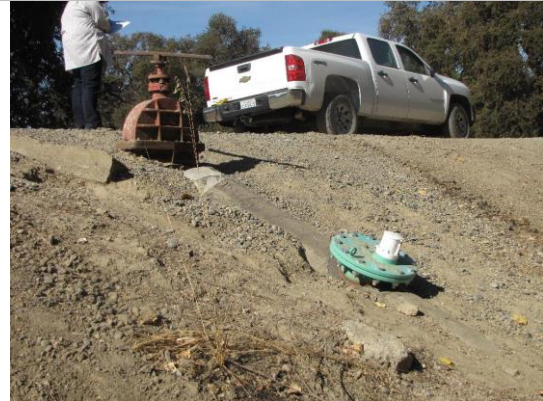
Photo 2 of 3 : UCIP_FA_2015_6491.jpg

Gate valve and exposed section of the pipe located on waterward side.

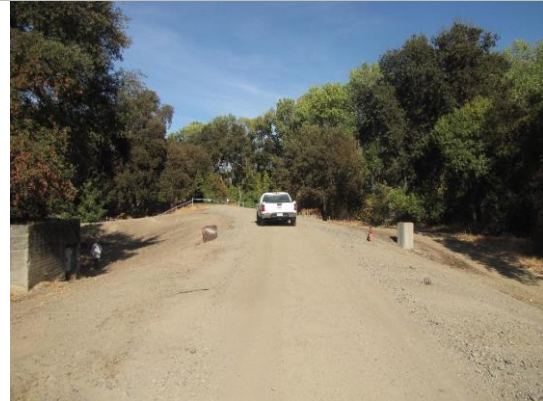
Photo 3 of 3 : UCIP_FA_2015_6492.jpg

Action/Comments					
Inspector Comments: FS_ID:44600					
DS_ID:16436					
EP_NO: 4213					
FS_HLM: 3.763					
Repair Type: Urgent					
Crossing Status: Found					
UCIP Comments: 4/20/2015 Sink hole over pipe alignment on LS up against the concrete building. Need to dig up pipe and see if its leaking.Recommend adding door to LS concrete structure. Riser located on landward side is damaged. This crossing was listed in the USACE Periodic Inspection as ID#					
USACE_CESPK_MA1C_2010_p_0194 no issues logged.7/18/2013					
Same as last inspection.12/17/2013 Same as last					
inspection.6/18/2014 Same as last inspection.6/23/2014 Same as last inspection.					
FIELD_STRUCT_DESC: 24-inch pipe through the levee. Gate valve on waterward shoulder. 1-1/4 inch conduit through the levee. Siphon breaker on the landward shoulder. Concrete pump house. (Permit No. 4213-1973, Scott Ranch)					
FS Date: 04/21/2015

Overview of levee crown looking upstream at crossing.

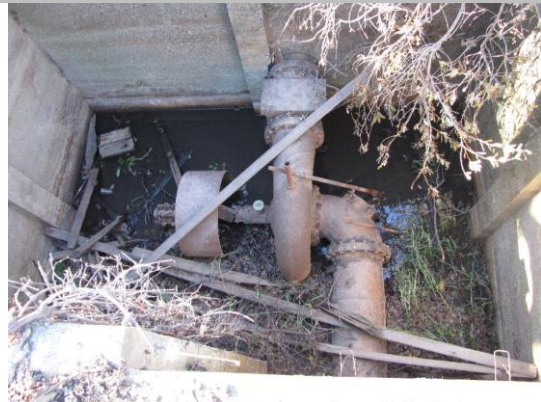
Photo 2 of 3 : UCIP_FA_2015_5082.jpg

Abandoned pump system inside concrete structure located on landward side.

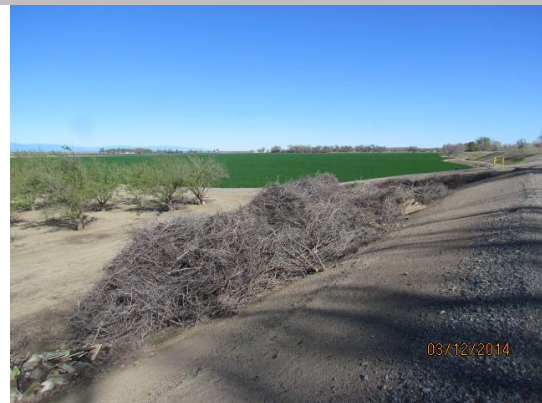
Photo 1 of 1 : FA_2015_MA0001_297_77_20150910_00020.jpg

View of the prunings along the landside toe.

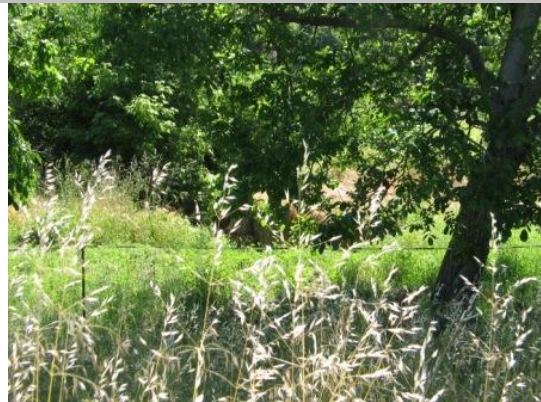
Photo 1 of 1 : FA_2015_MA0001_297_18_20150910_00008.jpg

View of the erosion along the waterside of the levee.

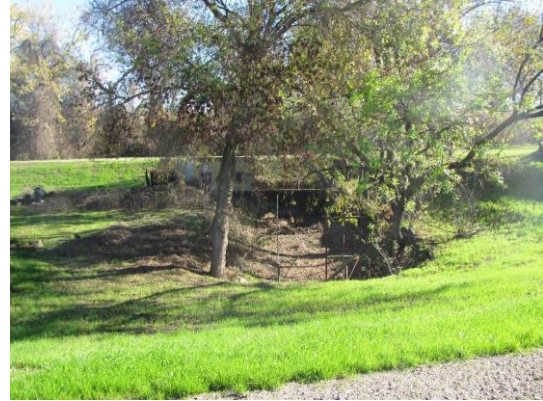
Photo 2 of 3 : UCIP_FA_2015_6619.jpg

View of abandoned structure located on waterward side (inside ring levee).

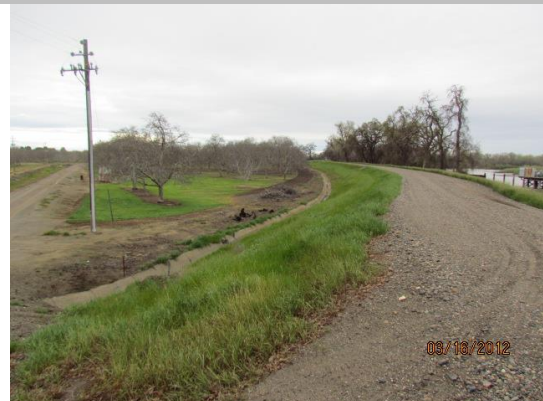
Photo 1 of 1 : FA_2015_MA0001_297_27_20150910_00012.jpg

View of the ag. ditch along the L/S toe.

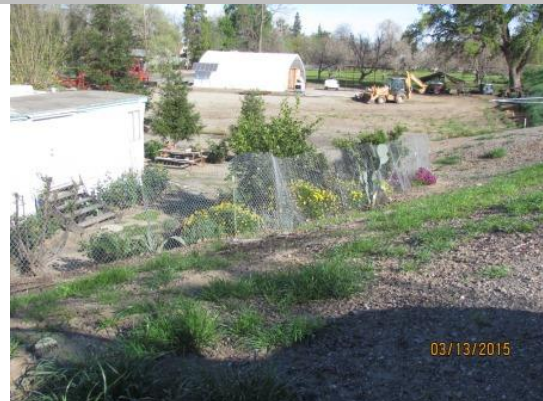
Photo 1 of 1 : FA_2015_MA0001_297_74_20150910_00018.jpg

View of the landscape along the landside slope and toe.
